FINAL REMOVAL ACTION WORKPLAN

**837 INDUSTRIAL ROAD
TANKLAGE SQUARE
SAN CARLOS, CALIFORNIA**

GEI PROJECT: B10655

OCTOBER 24, 2014

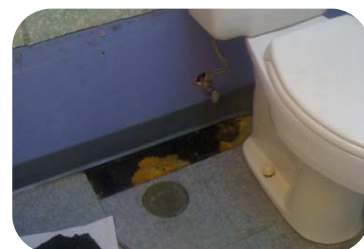
New drywall installed, flooring uncovered and toilet re-installed

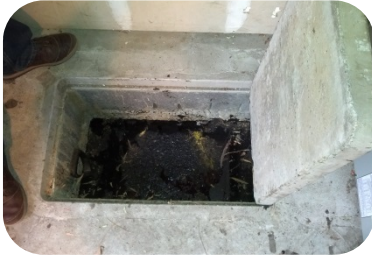
Sump with concrete plate,
located in electrical room

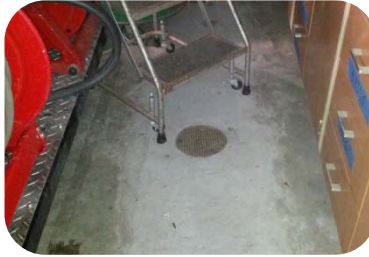
Concrete covered trench with
access plate (Suite D)

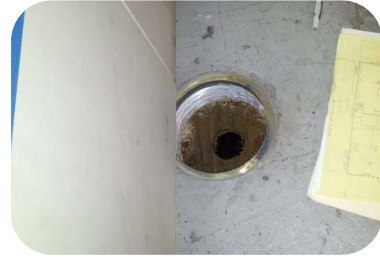
Access plate (Suite D)

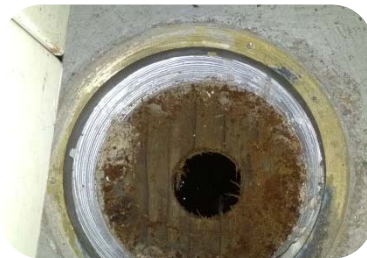
Access plate (Suite D)

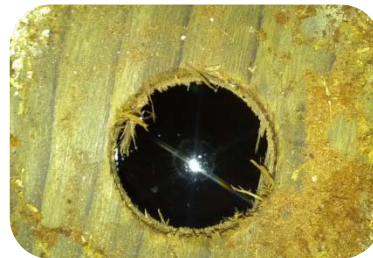
Access plate with tar-like
substance visible in trench
(Suite D)
